# **The Commonwealth of Massachusetts**

### **PIPELINE ENGINEERING AND SAFETY DIVISION**

## **INCIDENT REPORT**

627 Pleasant Street, Winthrop, Massachusetts  
February 23, 2012

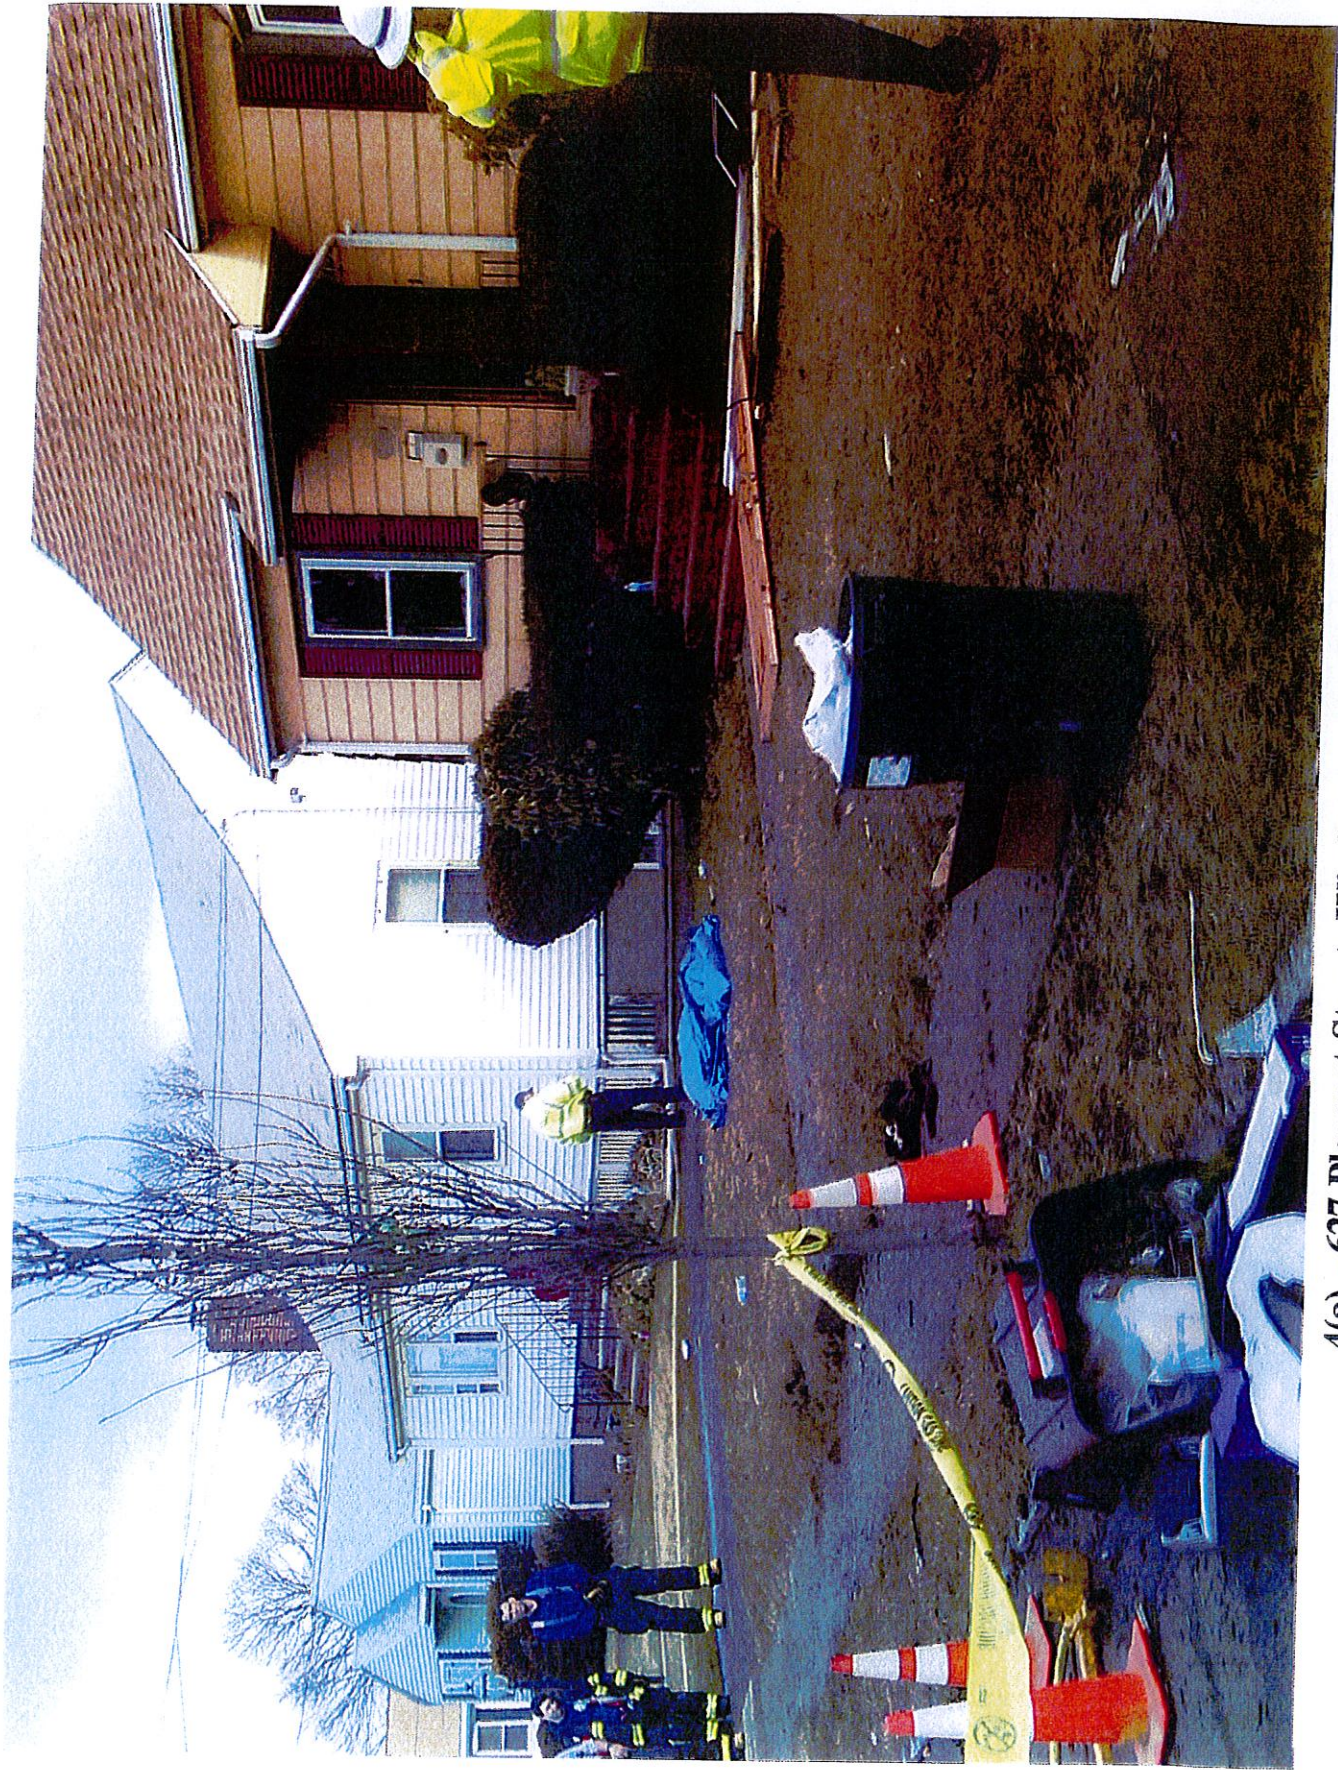
4(a) - 627 Pleasant Street, Winthrop - Residential Area

Pleasant Street, Winthrop is located in a residential area comprised of single family homes (Exh. 4(a)). The structure at 627 Pleasant Street was a two-story wood frame house with a basement. The house was constructed in 1850. The Division investigator observed that the natural gas service line entered through the right front basement wall. The gas furnace, hot water heater and dryer were located in the basement (Exh. 4(b)). A gas stove was located on the first floor of the house (Exh. 4(c)).

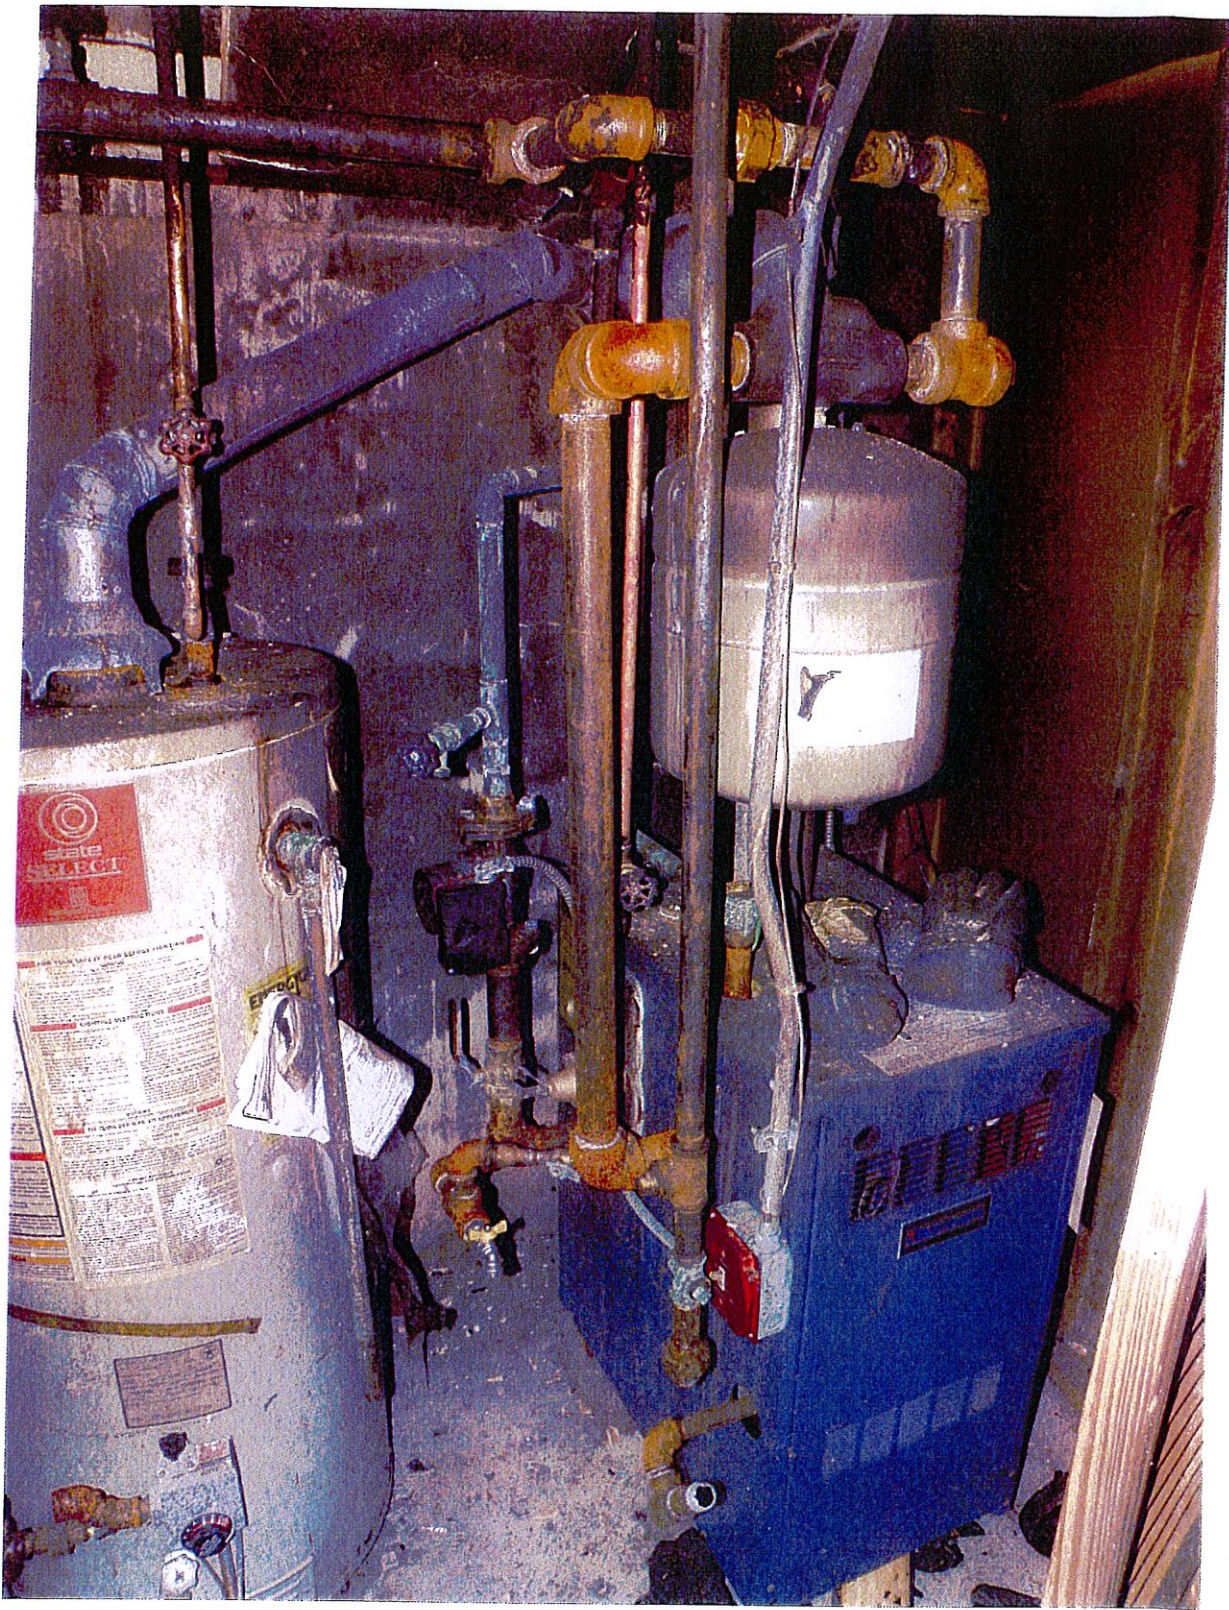
4(b) - 627 Pleasant Street, Winthrop – Furnace and water heater in basement

In the basement, the inspectors observed: (1) the gas service entrance and meter on the inside right front foundation wall; (2) a water heater and furnace located in close proximity to the service entrance; (3) a washer and dryer in the back of the basement; and (4) a sewer trap and sump pump in the basement floor near the center of the inside front foundation wall of the house. On the first floor, the inspectors observed a gas stove in the kitchen area (Exh. 4(c)).

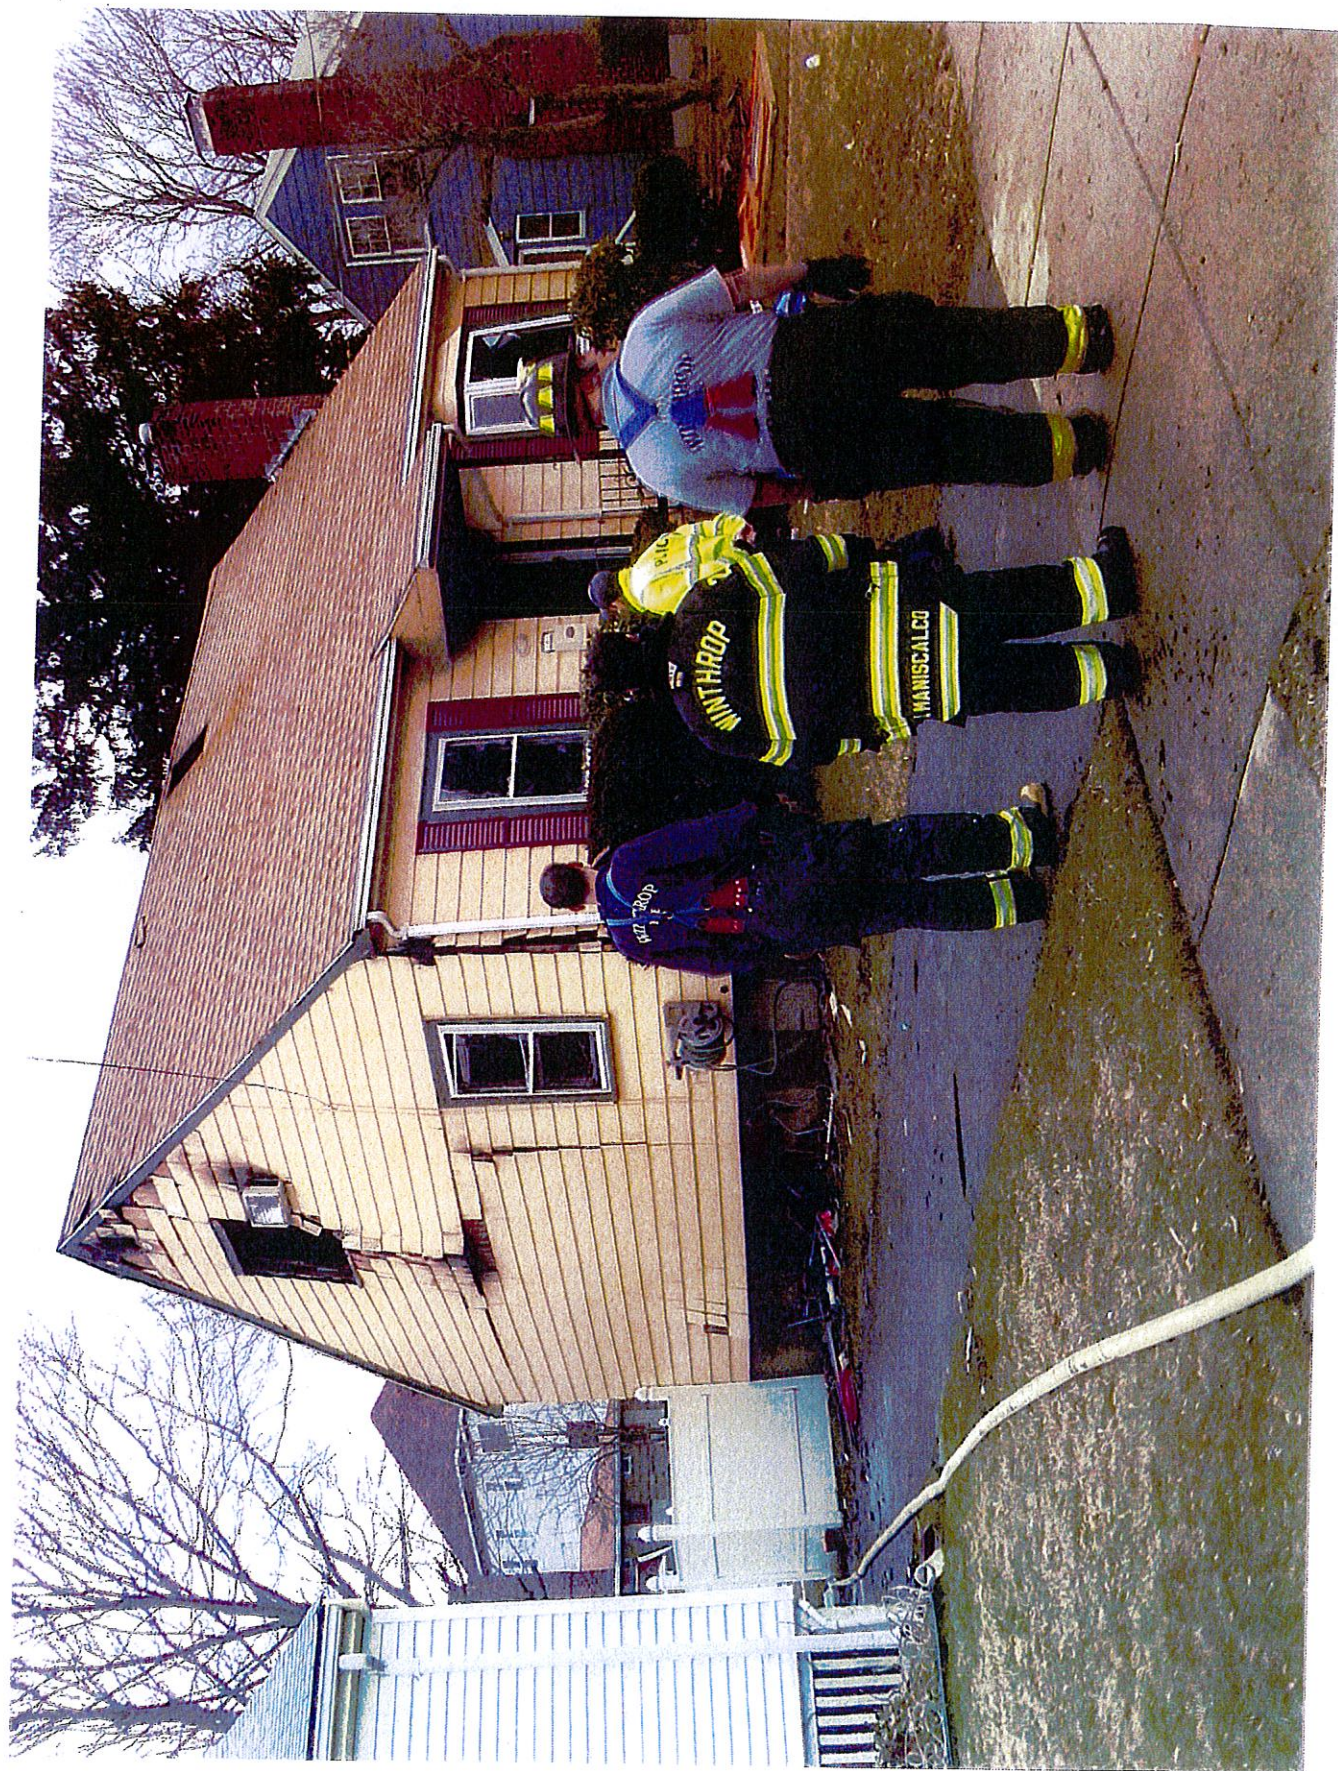
The building had been severely damaged by an apparent explosion and subsequent fire (Exhs. 4(d), 4(e)). Debris was blown onto the lawn of 627 Pleasant Street, and adjacent properties (Exh. 4(e)). In addition, the windows and walls were displaced.

4(d) - 627 Pleasant Street, Winthrop - Fire Damage

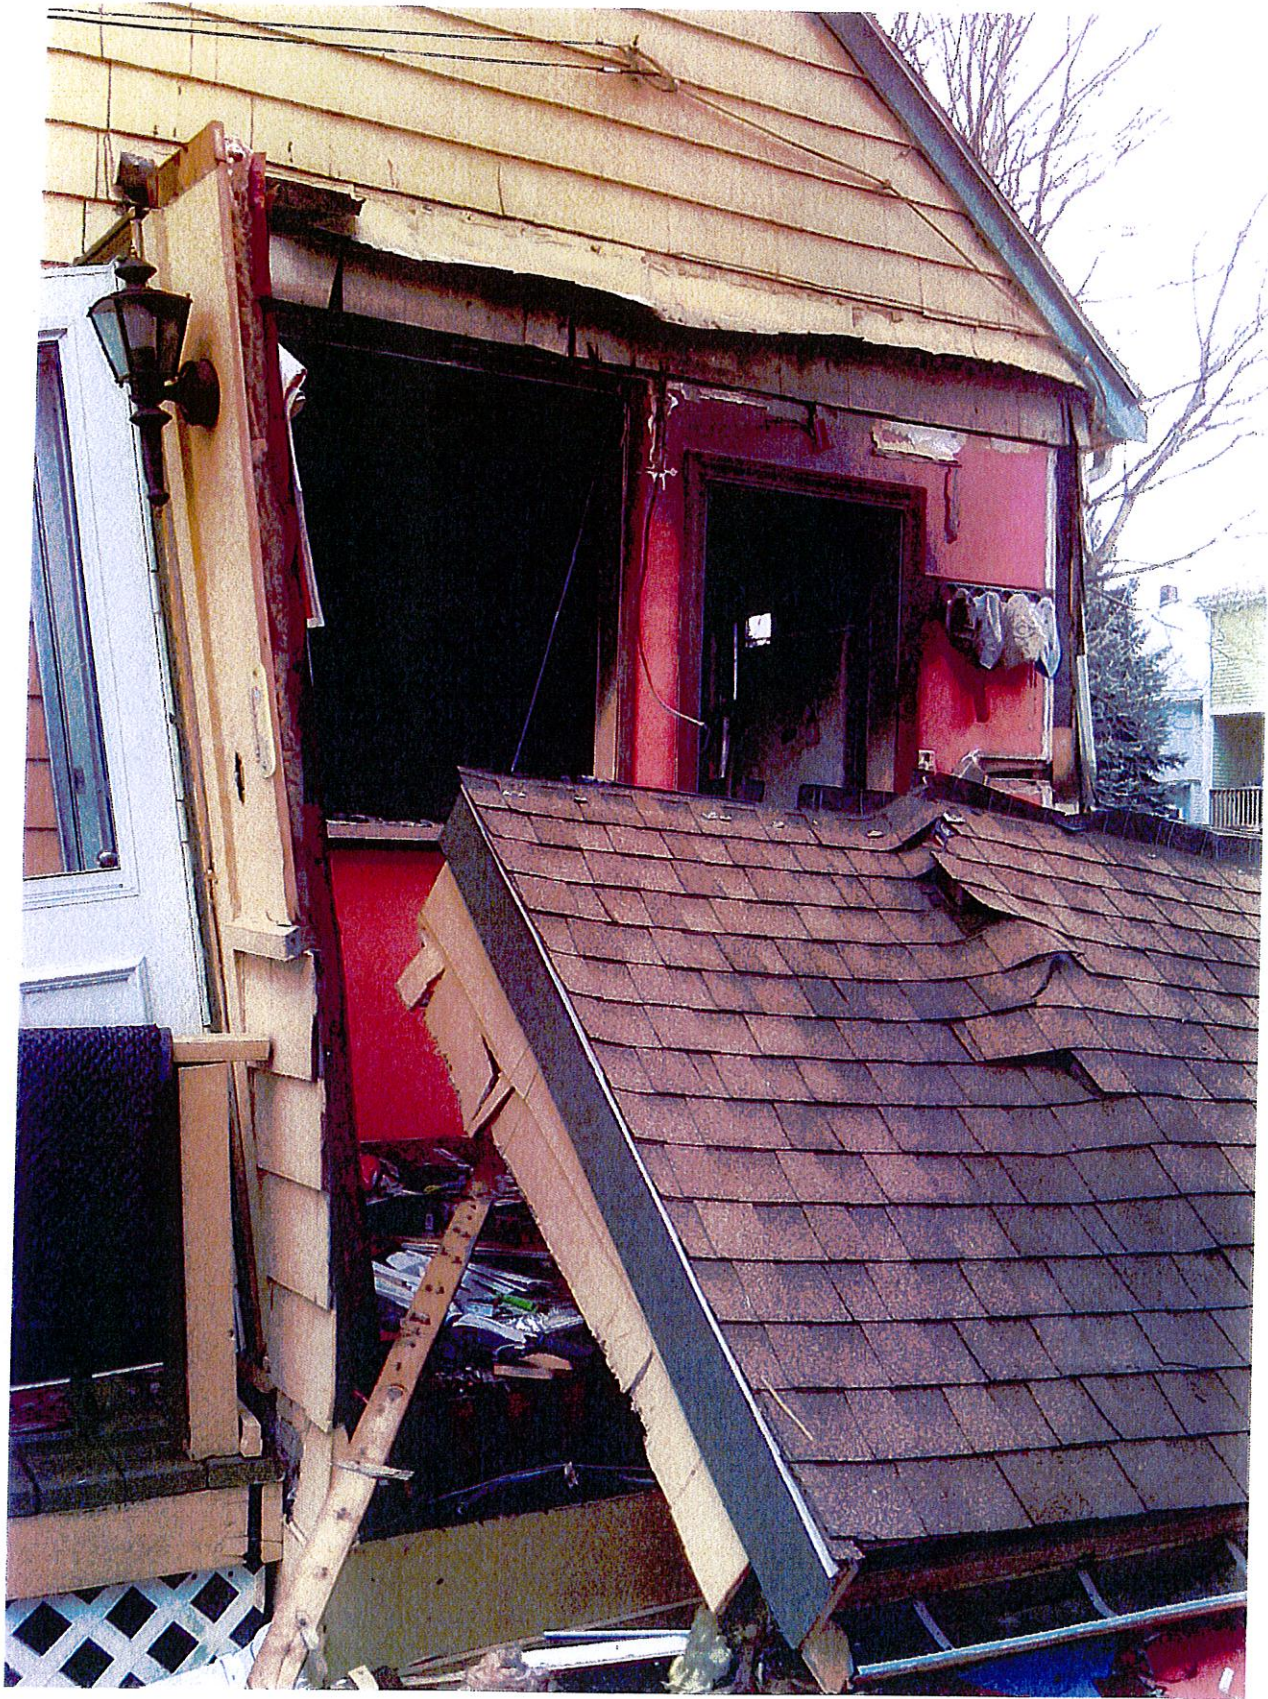
4(e) - 627 Pleasant Street, Winthrop – Debris on right side of structure

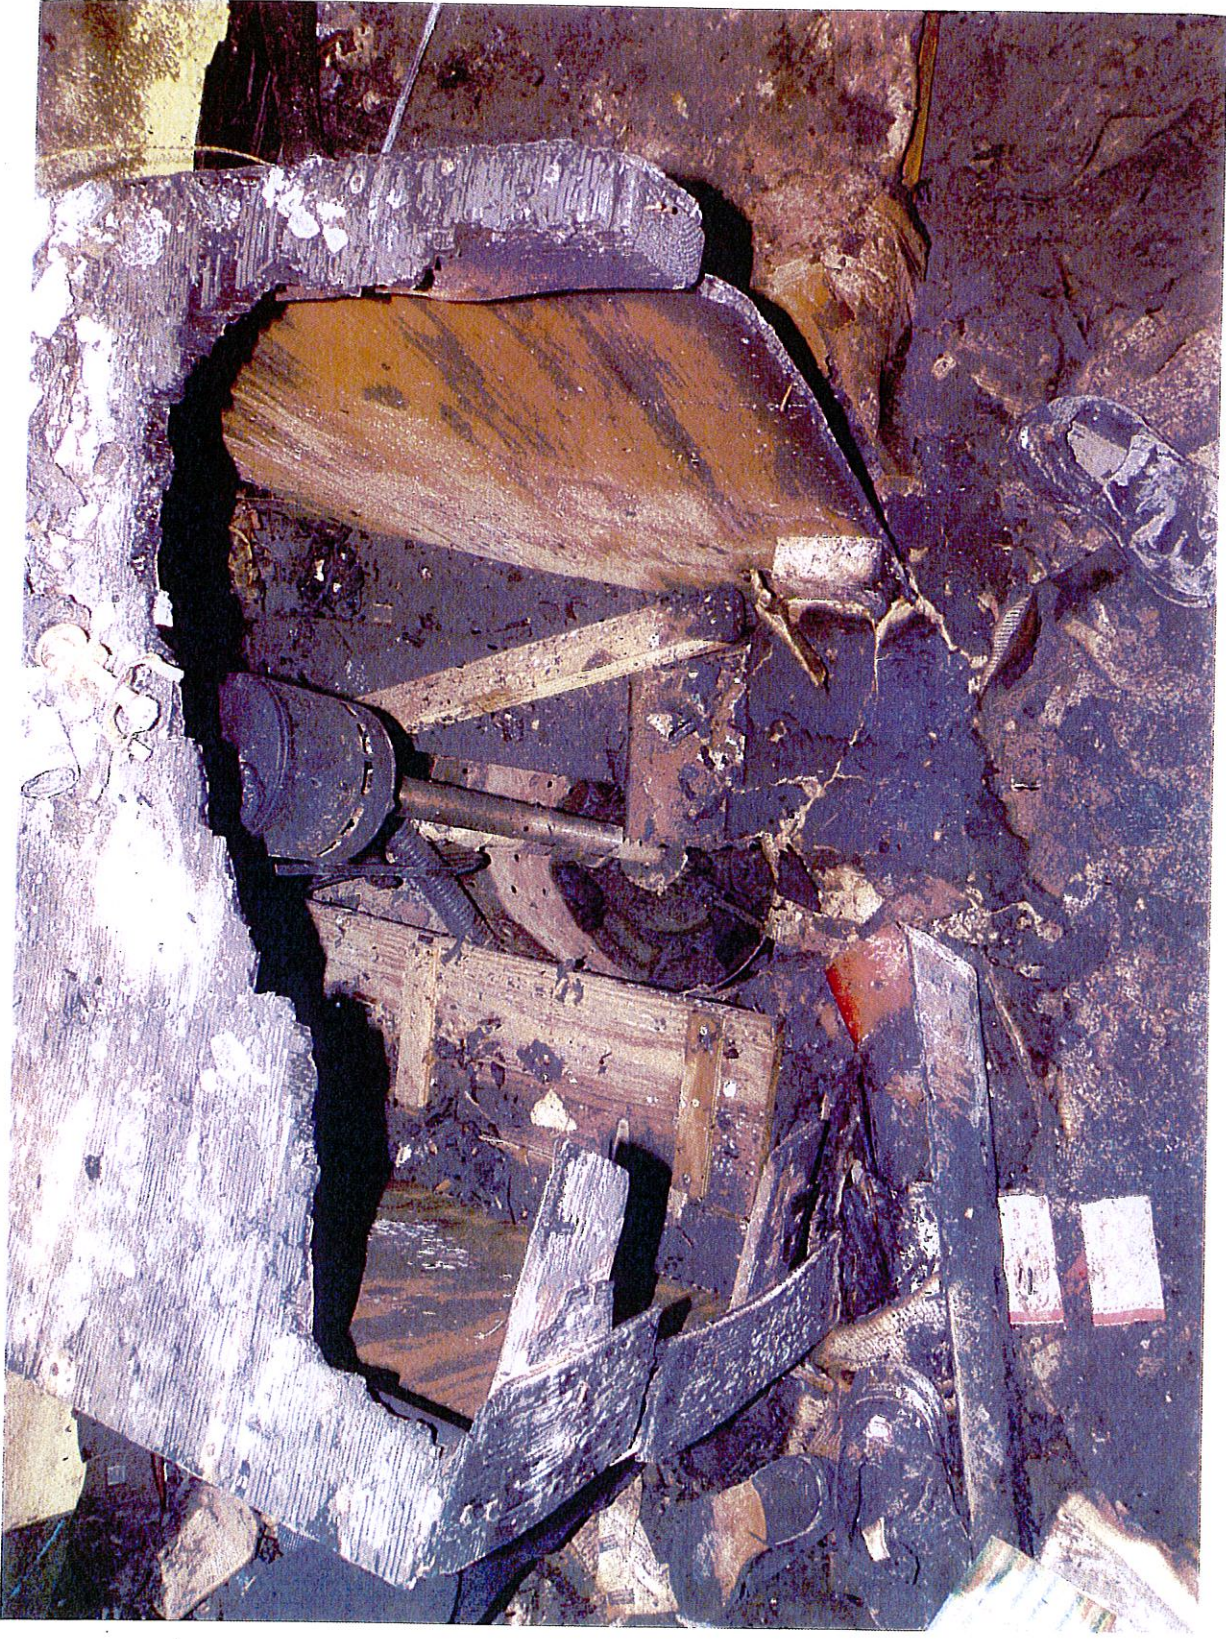
4(f) - 627 Pleasant Street, Winthrop - Sump pump in basement floor

The Division inspector observed the Operator conduct an internal inspection of the sewer line, from the sump pump area inside of 627 Pleasant Street, to the main sewer line located in the street. The sump pump was located at the center of the inside front foundation wall of the house in a covered box in the basement floor; the box also contained the water line (Exhs. 4(f), 4(g)). During the inspection, the Division inspector noted the following:

1. The clay sewer drain line had been repaired with plastic (PVC) sometime prior to the incident.
2. The plastic portion of the sewer drain was a repair thirty eight (38) feet from the foundation wall, there the plastic sewer drain line continued another fifty (50) feet to the end of the pipe.
3. A leak in the drain line was detected twenty five (25) feet from the foundation wall, and water was pouring into the sewer pipe.
4. The chimney on the end of the sewer pipe is fifty (50) feet from the foundation wall and it takes a ninety degree bend downward. The length of that section of pipe from the bend to the main line sewer is seven (7) feet.
5. A tree root was visible inside the drain pipe, nine (9) feet from the foundation wall.

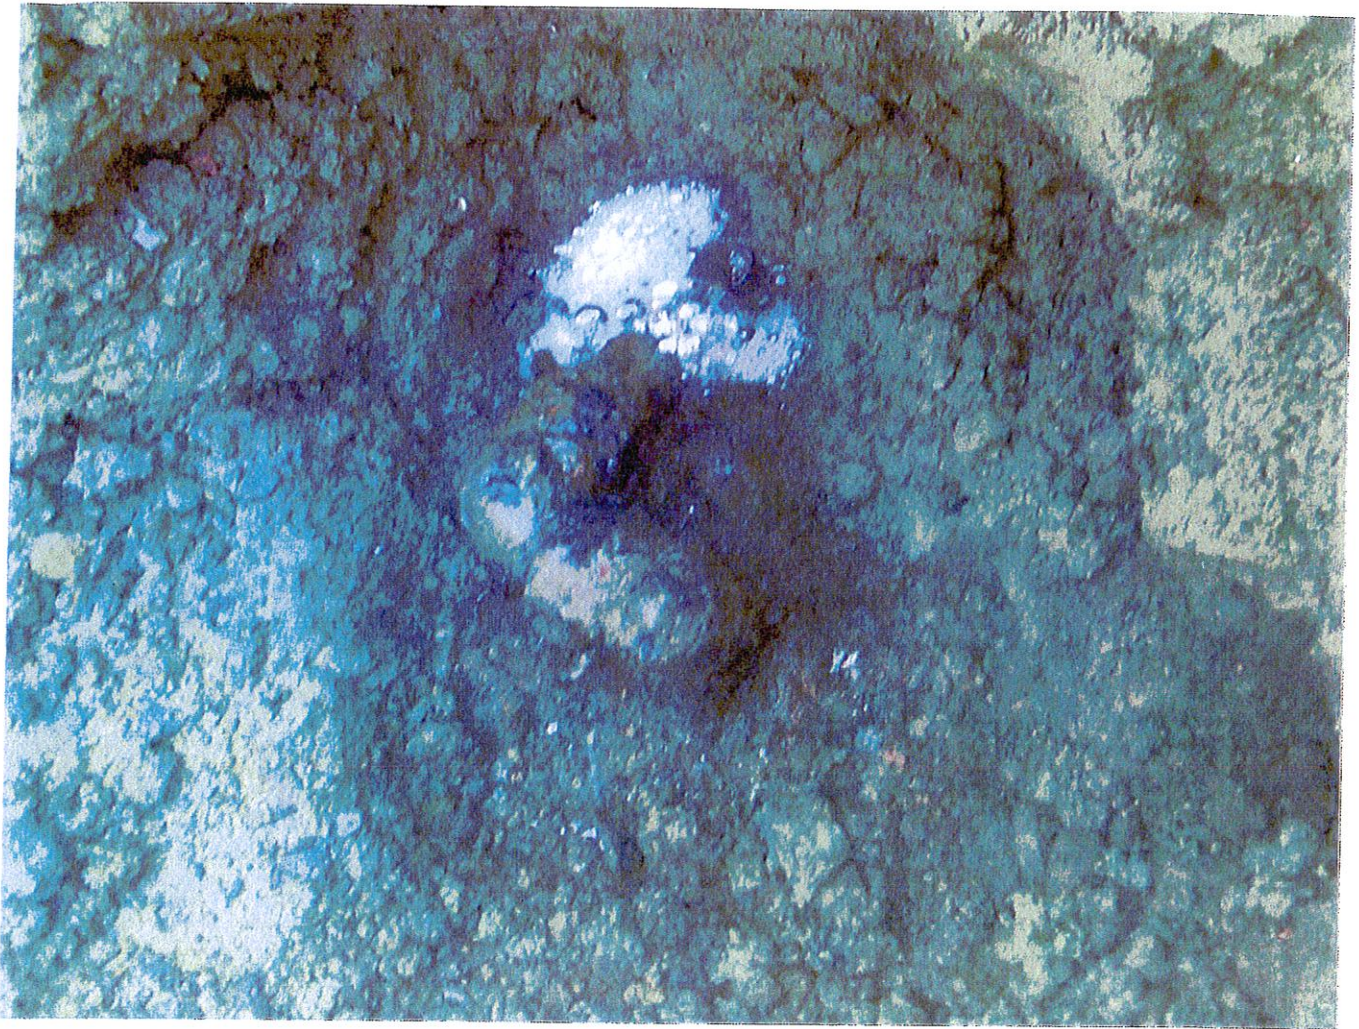
The Operator excavated at the gas main, and found a leak at the one (1) inch plastic service line transition fitting downstream of a saddle fitting attached to the six (6) inch cast iron main (Exh. 8(a)). The Division inspectors observed that soil in the area of the leak was a

8(a) – Leak at saddle transition fitting attached to the six inch cast iron gas main

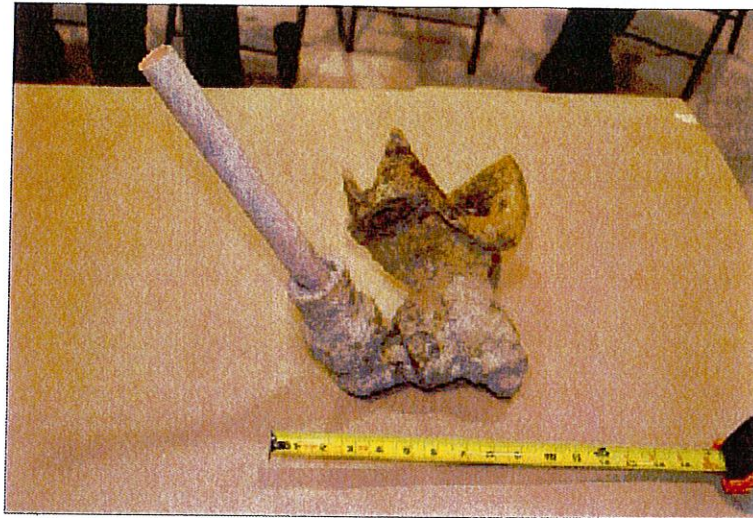
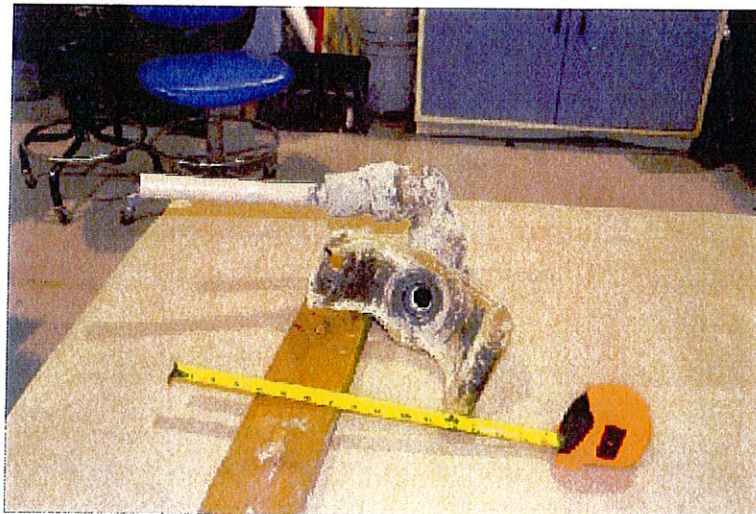
dense clay material. The Operator removed, and the Department secured, the service saddle, transition fitting, and approximately one foot of pipe that included the leak location (Exh. 8(b)).

Figure 10: The saddle fitting assembly, top view.

Figure 11: The saddle fitting assembly, bottom view. Note plastic service pipe is askew.

8(b) – Service saddle transition fitting and plastic pipe that was attached to the six inch cast iron gas main

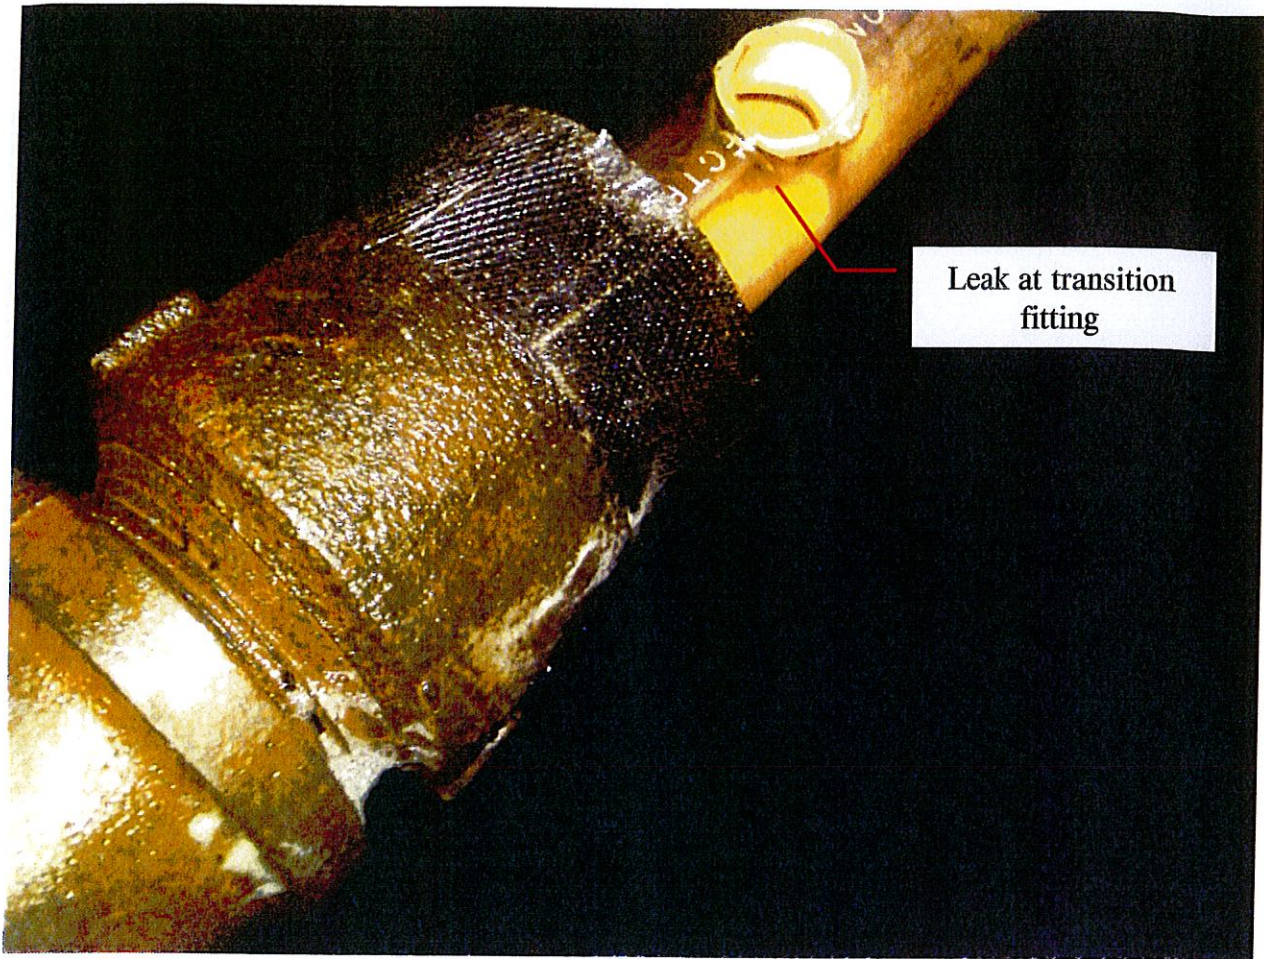
The Operator excavated in the front lawn of 627 Pleasant Street, and uncovered the plastic service line inside a steel sleeve. The line extended from inside the house foundation wall to the area in the sidewalk where the Operator detected a fifty five (55%) percent gas reading (Exhs. 7(a), 7(c)). When the Operator exposed the gas service inside the house they found a half (1/2) inch hole in the plastic pipe at the transition point of the internal stiffener located inside the foundation wall (Exhs. 8(c), 8(d), 8(e)).

Leak at transition  
fitting

8(c) – Leak at transition fitting inside the basement at the foundation wall

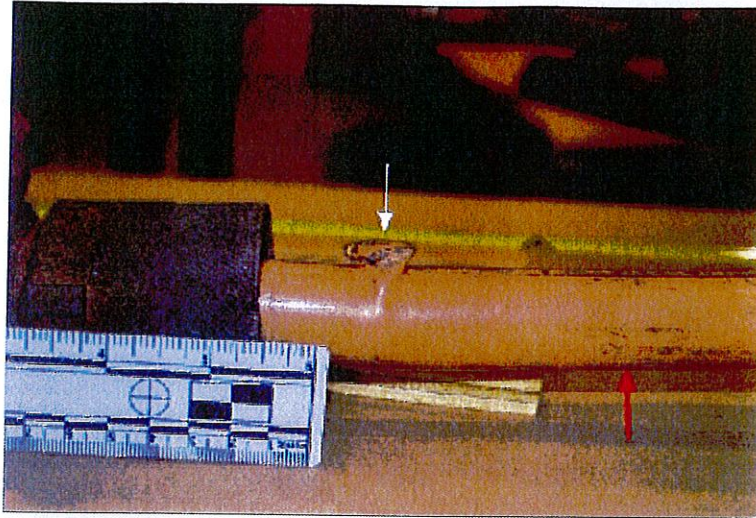
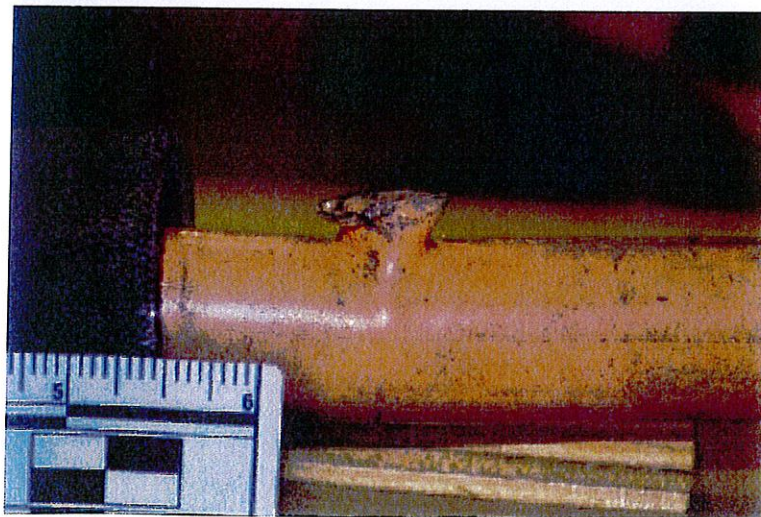
The service line hole possessed the thinning and general morphology of a blow-out type hole. This is consistent with heat exposure and is a result of the incident. The service line within the transition fitting also exhibited obvious heat damage. The service line 180-degrees to the blow hole was unremarkable, (MMR Project No. 92941 - Page 3 See Exh. 8(d)).

Figure 5: Service line blowhole adjacent to the foundation fitting, white arrow. The service line was bowed on this end, red arrow.

Figure 6: Detail of blowhole. This damage was heat related.

8(d) – Leak at transition fitting inside the basement at the foundation wall

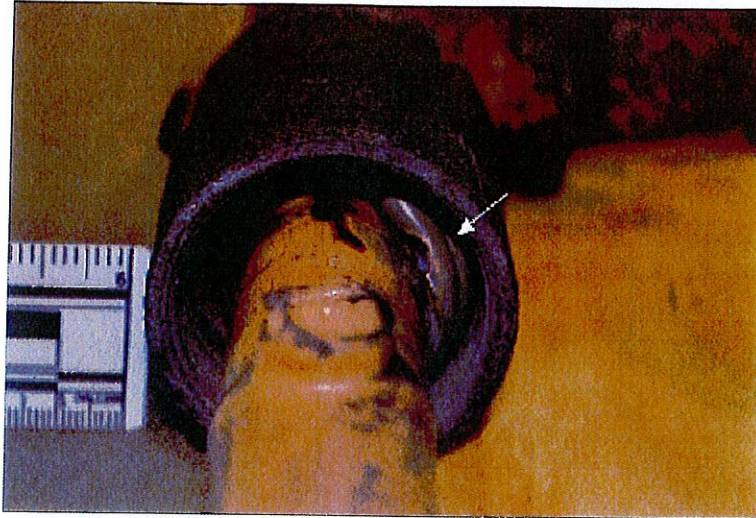
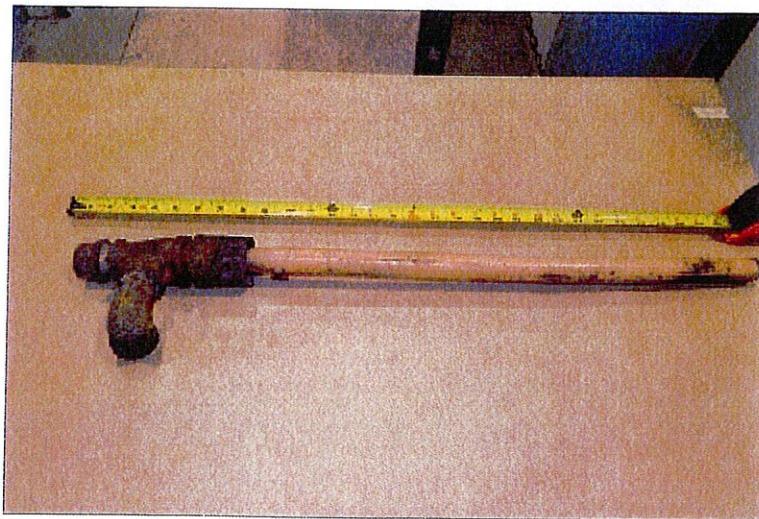
Figure 7: Melted plastic was visible within the foundation fitting, arrow. This was heat related.

Figure 8: The underside of the foundation fitting assembly and service pipe were unremarkable.

8(e) – Leak at transition fitting inside the basement at the foundation wall

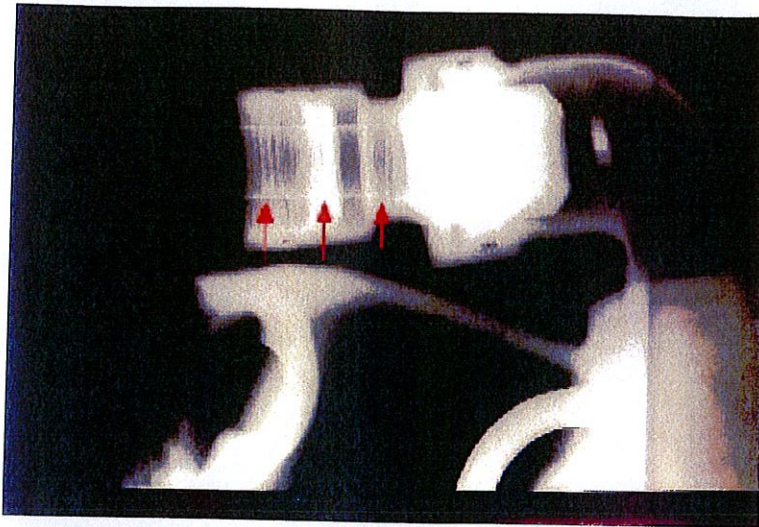
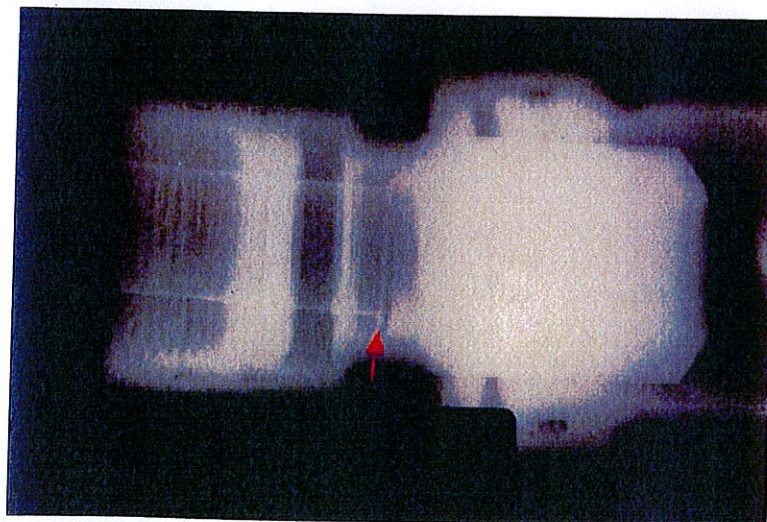
With respect to the saddle transition fitting mounted on the gas main. MMR noted that[t]he saddle fitting stiffener was askew in the joint (Exh. 8(f)). MMR concluded that:

Putting enough bending force on a plastic service line to angle a stiffener in a transition fitting creates a severe situation for the plastic component. This is a condition created at assembly of this transition fitting during the 1986 steel service replacement (MMR Project No. 92941, at 4).

Figure 21: The stiffener in the saddle fitting was obviously askew, arrows.

Figure 22: Saddle fitting stiffener detail, arrow.

8(f) -Transition fitting attached to the six inch cast iron main saddle

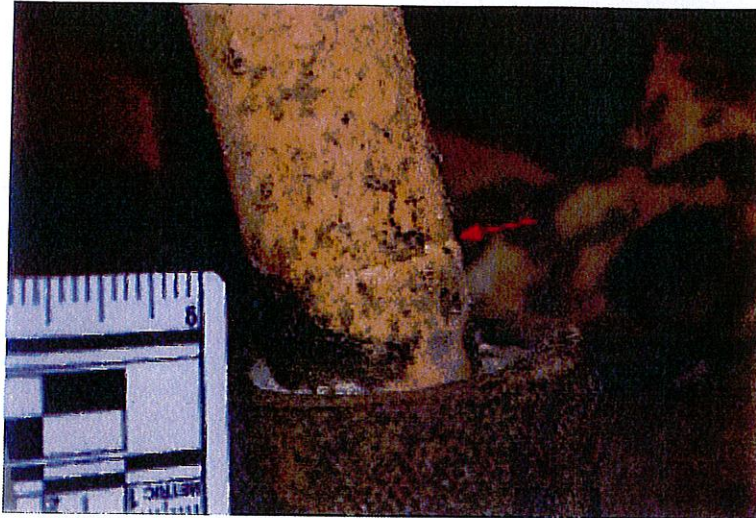
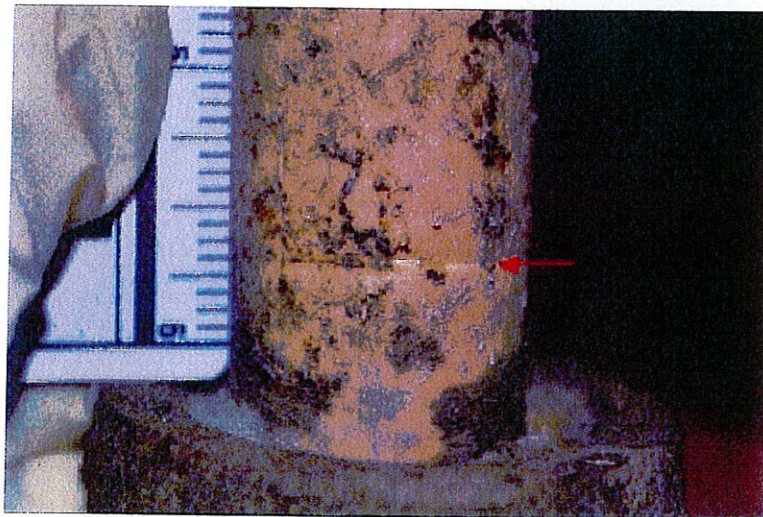
A crack was present in the plastic service pipe at the edge of the saddle transition fitting stiffener. The saddle fitting stiffener was askew in its joint and the pipe was angled exiting the transition fitting. The crack was caused by the bending and other forces on the plastic pipe combined with internal impingement on the end of the stiffener. This arrangement appears to have been the result of installation. The measured leak rate in the laboratory was 17.5 ml/min. This leak rate may be lower than the in-service rate as cutting the plastic pipe to remove the saddle would relax service stresses and could have closed up the breach a bit (MMR Project No. 92941, at 7).

Applying enough force on a plastic pipe to skew the transition fitting internals and then installing the pipe to leave that force intact places undue loading on plastic piping in general. When the resulting configuration causes that plastic pipe to press against the edge of a metal component, a crack like that present in the incident pipe is the logical outcome (MMR Project No. 92941, at 7) (Exhs. 8(g), 8(h), 8(i)).

Figure 24: Detail of saddle fitting service pipe after cleaning. Note scrubbed surface texture and dimpled region, arrow.

Figure 25: Facing view of saddle pipe dimple, arrow.

8(g) – Leak at transition fitting attached to the six inch cast iron main saddle

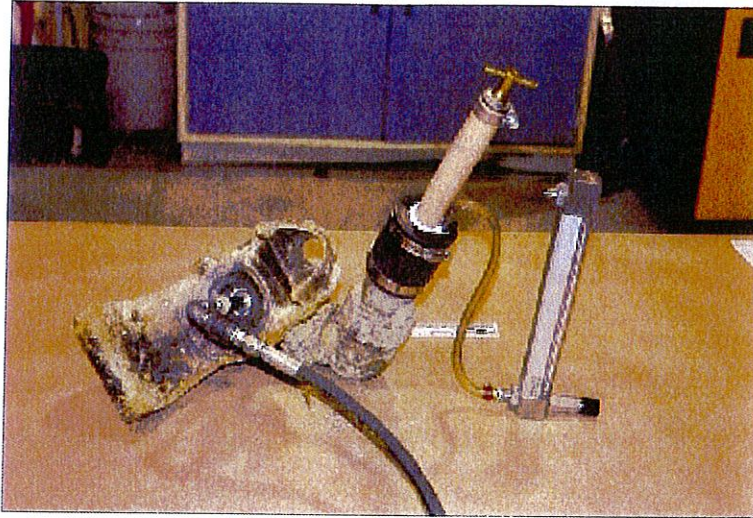
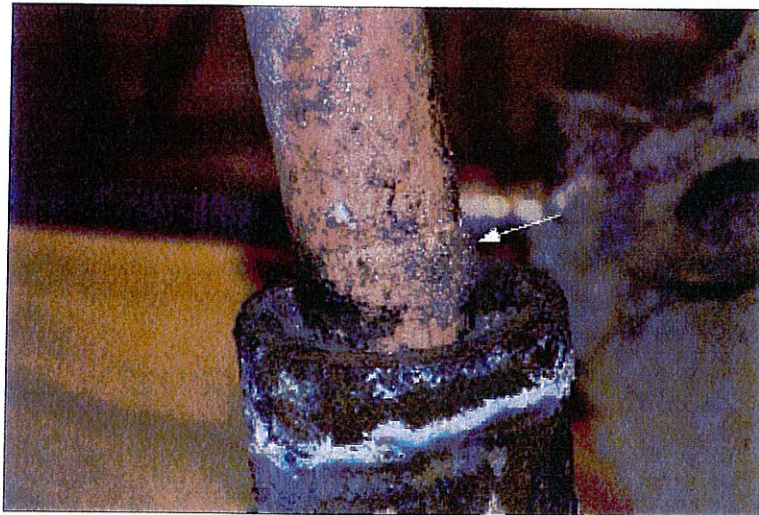
Figure 26: The leak testing apparatus.

Figure 27: The dimpled region was the source of the leak, not the transition fitting, arrow.

8(h) – Leak at transition fitting attached to the six inch cast iron main saddle

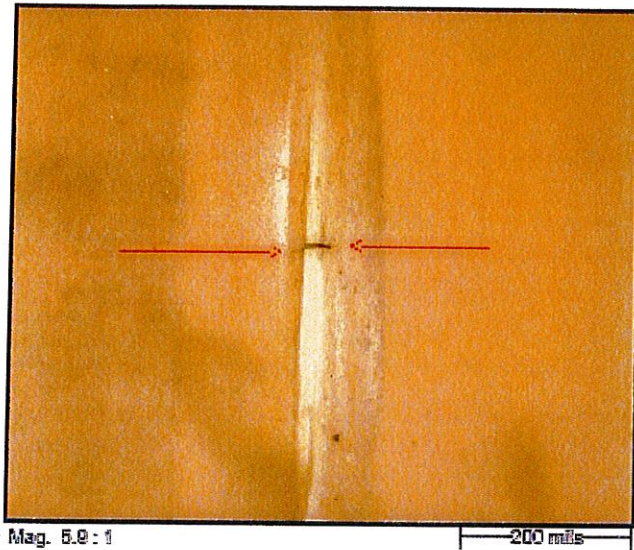
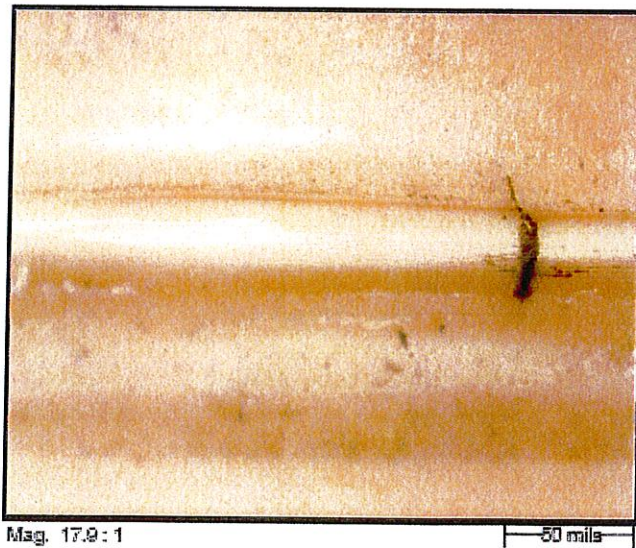
18. The MMR conclusion that, the plastic service pipe cracked at the edge of the saddle transition fitting attached to the main is reasonable, and supported by substantial evidence.

19. The MMR conclusion that, the cause of the crack was bending and other forces on the plastic pipe, combined with the internal impingement on the end of the

- stiffener on the saddle transition fitting, is reasonable, and supported by substantial evidence.
20. The MMR conclusion that, when the gas service line transition fitting assembly was leak tested and that "the leak rate may be lower than the in-service rate as cutting the plastic pipe to remove the saddle would relax service stresses and could have closed up the breach a bit," is reasonable and supported by substantial evidence.
  21. The MMR conclusion that the leak in the service line at the transition fitting in the foundation wall of 627 Pleasant Street is consistent with heat exposure, and a result of the Incident, is reasonable and supported by substantial evidence.
  22. The Operator did not provide substantial and specific evidence to support a finding that the most probable source of the release of gas was on a faulty valve on the customer's owned piping.

Figure 40: Saddle fitting ID with leak at arrows.

Figure 41: Detail of Figure 40 showing the crack and plastic stretching.

8(i) - Leak at transition fitting attached to the six inch cast iron main saddle

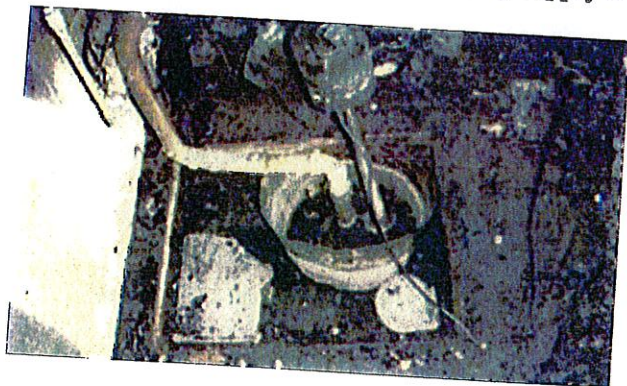
The examination centered around the sump pump area to determine if a leak in the drain pipe occurred and allowed the migration of gas vapors into the dwelling. The area around the sump pipe was excavated and tested with no conclusions. Further examination was requested by the home owners insurance investigators to scope the drain pipe.
